**NATIONAL PRIORITIES LIST (NPL)**

**LUSHER STREET GROUND WATER
CONTAMINATION****Elkhart, Indiana***Elkhart County***Site Location:**

HRS DOCUMENTATION RECORD COVER SHEET

Name of Site: Lusher Street Ground Water Contamination
EPA ID No. IND982073785

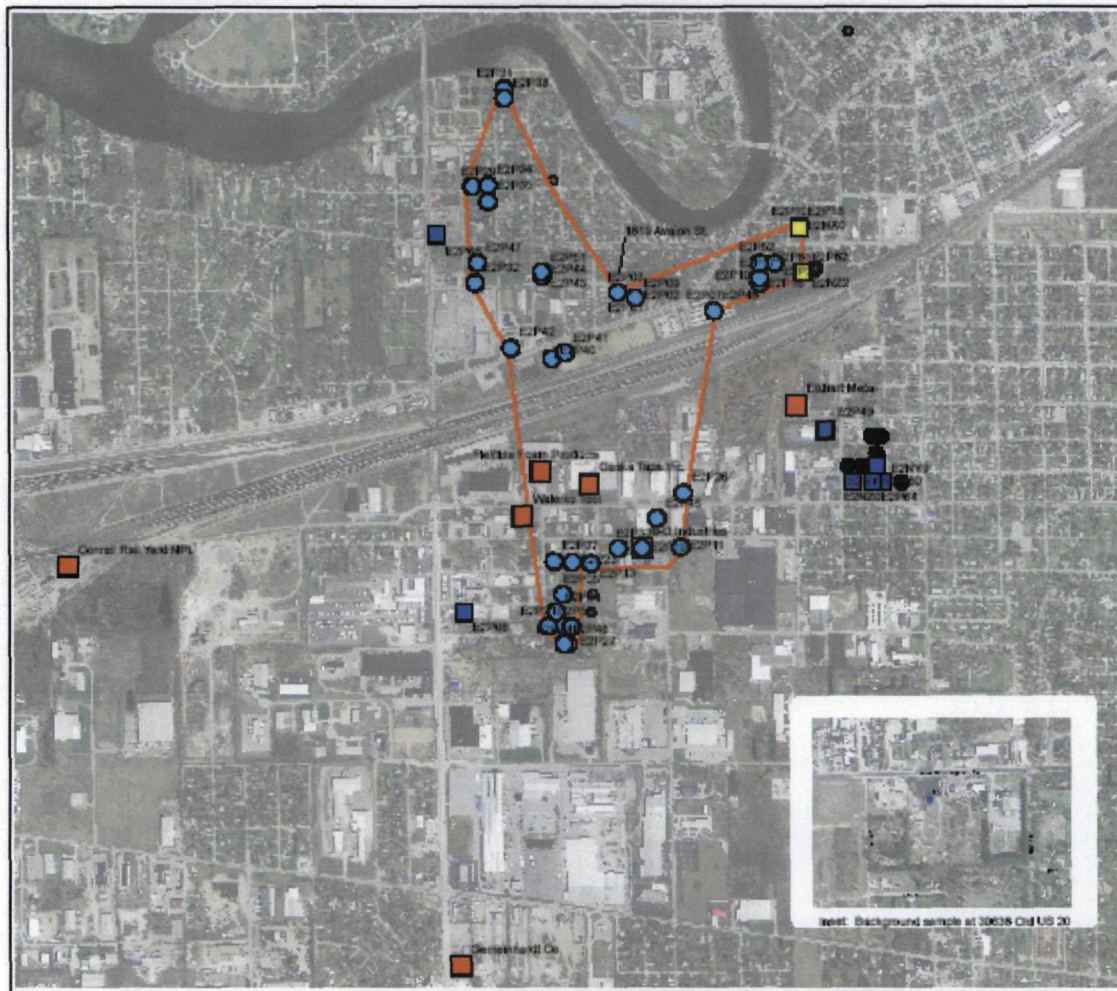
Ground Water Plume Boundary Map
defined by Chlorinated VOCs from Key Findings Lists,
Events 3, 4, & 5 including Potential Sources
Lusher Avenue Site, Elkhart, IN, IND982073785

Source:
 2005 Orthophotos - Color aerial imagery collected in Spring 2005, as part of the Indiana Statewide Orthophotography Project. Points for sample locations were located using a combination of digitizing and georeferencing. The georeferencing was conducted using USGS 1:250,000 scale maps that could be located using georeferencing where located using sample maps and project image georeferencing.
 The sample points represent samples collected during sample events 3, 4, and 5. The yellow and blue points represent locations where chlorinated VOCs were detected at concentrations greater than the detection limit. The ground water plume boundary was defined by drawing a line connecting the outer most ground water wells with lower detection (greater than detection limit) of chlorinated VOCs based on the Key Findings lists for events 3, 4, and 5 (event 1 and 2 data). Wells that showed a detection of a chemical without an MCL were not included in the Key Findings lists.

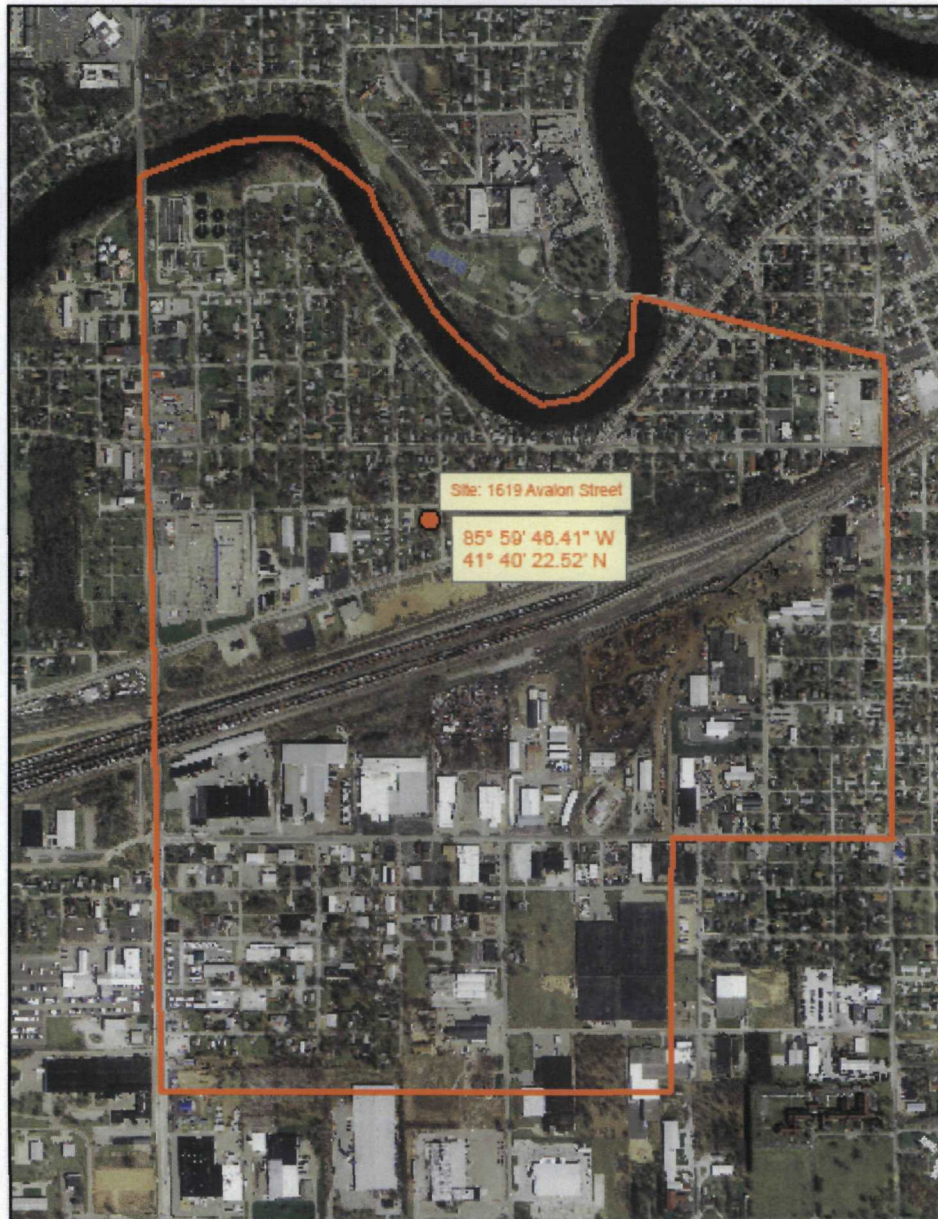
Lusher Avenue Ground Water Contamination Site, Elkhart County, Elkhart, IN

- 1619 Avalon St.
- Lusher Ave site Boundary
